In the village of San Ponso Canavese near Turin: the history of the restoration of the Baptistery of San Ponzio (first part)

Nel Villaggio di San Ponso Canavese vicino Torino la storia del restauro del Battistero di San Ponzio (prima parte).

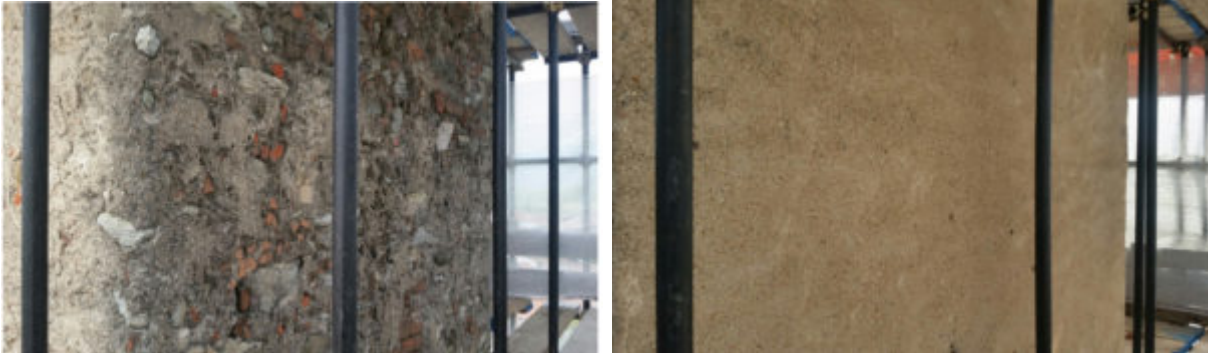
[In the picture 2 at the bottom left](#) the north front of the bell

tower: the coat was in such a bad state that after the cleaning and removal of those parts that couldn't be saved, there was barely any left. **In the picture 3 at the bottom right** the south front on the bell tower: here there was almost no biological patina, overall surface was consumed, fine aggregate lost, but the worn out effect was very beautiful.

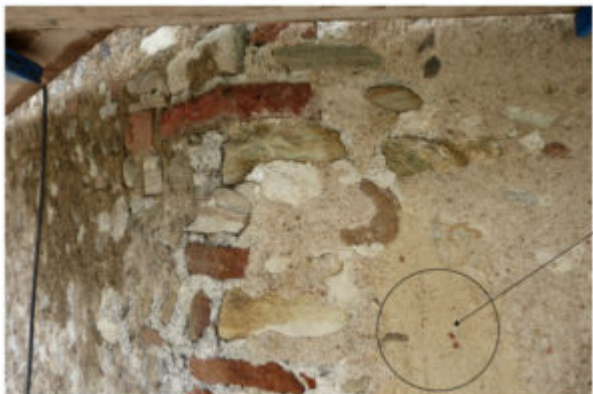
made mainly with a mix of **grey sand** and mostly a reddish **granite sand** coming from "Belmonte". **Belmonte** is a **natural park** at present and renowned until 1980 for his **particular stone** quarry with a unique color called "**Rosso Belmonte**". Surfing the internet it's possible to find manufacturers that nowadays are selling a substitute for this fine, but out of production, material. As a final thought: the whole mountain has a lot of **clay deposits** and this material, with the granite sand, flows naturally into small water channels, eventually forming small fluvial deposits mixed with dirt kilometers away from the point of origin. My guess is that the last coat was made using a "not so clean" **aggregate** and for this reason the final color was dark so weathering had so much of an impact on it. Below you can see another portion of the **dome surface**: it shows clearly that also here we had to take care of a **complex of materials**, some of them we removed because were made with **cement** or in such a poorly way that conservation was out of question ([picture 4 on the top left](#)).

[In the picture 5 at the bottom left](#): this is a restoration work made during last century. They tried to copy the clayish mortar adding pigment and smashed bricks to imitate the red sand but it was a failure. Won't tell much more about this here but cement was used in a poor way.

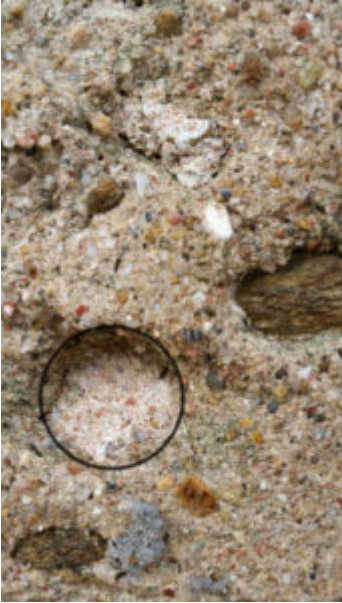
I hope this picture ([picture 6 on the left](#)) will help to make clear the difference in color of the two coats. The black circle points out a portion of the older one: the contrast between them is sharp. The last portion, the baptistery, was **badly damaged** at the base. Water falling from a roof without a gutter and a bad fixing intervention made with cement forced us to a massive removal. **Reconstruction** was made using lime mortar with structural properties and adding small quantity **crushed bricks** and marble 4-5 millimeters in diameter. Lastly the overall surface was left coarse in order to obtain a **good grip** for the future finish and also imitate the original weathered surface.
